# PLAY AREA SAFETY INSPECTION REPORT

Gosford and Water Eaton Parish Council

22 August 2016

Site Owner : **Gosford and Water Eaton Parish Council**  
Site Name : Gosford and Water Eaton PC - Kidlington Play Area  
Date of Inspection : 22 August 2016  
Inspected by : Mila Yearley

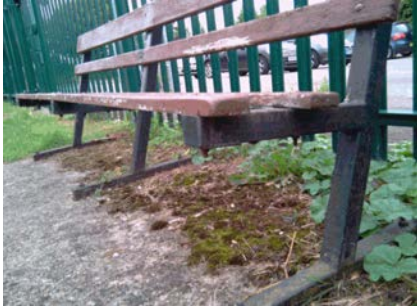
Facilities				
<p>Litter Bins</p> <p>Risk Score : 2 Risk Level : Very Low</p>	<p>Bins</p>	<p>Finding : RoSPA recommends that litter bins should not be closer than 2 m from seats and gates (max of 3 m recommended)</p>   <p>Finding Date : 22/08/2016 Task : Monitor and check on a routine basis</p>	<p>Low</p>	<p>5</p>
<p>Seating - Benches</p> <p>Risk Score : 3 Risk Level : Very Low</p>	<p>Seating</p>	<p>Finding : Item - Broken</p>   <p>Finding Date : 22/08/2016 Notes : Planks missing, loose, and / or broken.</p>   <p>Task : Repair item</p>	<p>Low</p>	<p>5</p>
<p>Seating - Benches</p> <p>Risk Score : 3 Risk Level : Very Low</p>	<p>Seating</p>	<p>Finding : Projecting bolt thread</p>   <p>Finding Date : 22/08/2016 Notes : Underside.</p>	<p>Low</p>	<p>5</p>

<p>Task : Cut off and file down to remove sharp edges</p>		
--	--	--	--	--

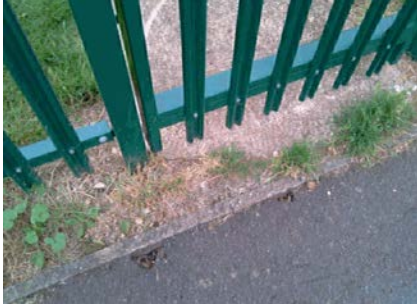
<p>Gate</p> <p>Risk Score : 4 Risk Level : Low</p>	Entrance	<p>Finding : Surface - Holes</p>   <p>Finding Date : 22/08/2016</p> <p>Notes : Holes in tarmac pavement by gate.</p>

<p>Task : Fill in holes</p>	Low	7
--	----------	--	-----	---

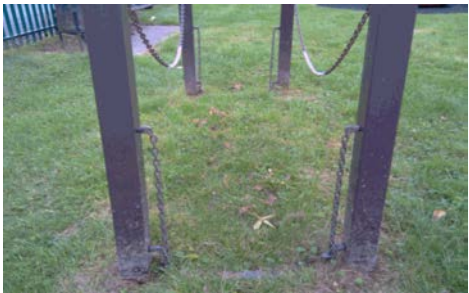
<b>Comments, action or control required</b>		<b>Risk Level</b>	<b>Risk Score ‡</b>
<b>Equipment</b>			
Finding : Item - Parts Missing  Finding Date : 22/08/2016 Notes : Wobbly beam missing.		Low	4

Task : Replace missing part / component			
<b>Surfacing - Grass</b>			
No remedial maintenance work is required at this time.			
<b>The overall risk for this item at the time of inspection:</b> ‡ For Risk Score see Report Notes		Low	6

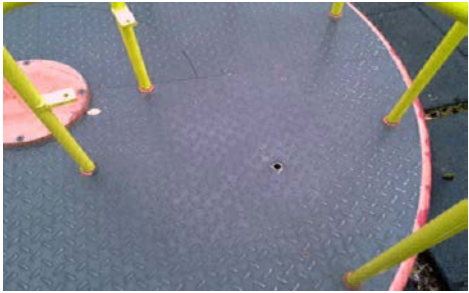
Comments, action or control required		Risk Level	Risk Score ‡
<b>Equipment</b>			
Finding :	Entrapment - Finger	Medium	8
Finding Date :	22/08/2016		
Notes :	The holes in the platform from the missing vertical rails create finger entrapments.

Task :	Eliminate entrapment potential

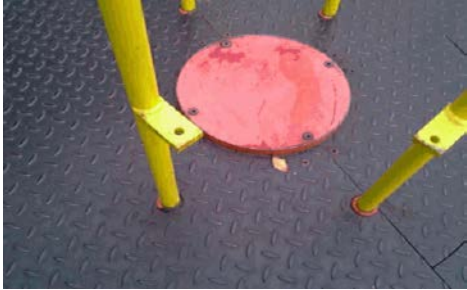
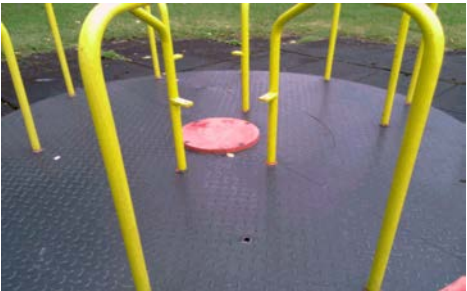
<p>Finding : Item - Parts Missing</p> <p>Finding Date : 22/08/2016</p> <p>Notes : Missing seat rails and seats, leaving exposed sharp metal corners in the free space which could cause injury.</p>

<p>Medium</p>	<p>12</p>
<p>Task : Replace missing parts</p> <p>Finding : Item - Rocking</p> <p>Finding Date : 22/08/2016</p> <p>Notes : Most of the vertical rails are loose.</p>

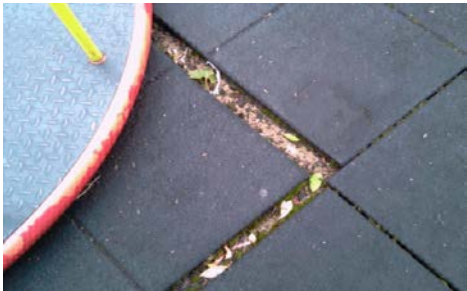
<p>Low</p>	<p>6</p>
<p><b>Surfacing - Rubber Tiles</b></p>		
<p>Finding : Surface - Tiles - Gaps</p> <p>Finding Date : 22/08/2016</p>

<p>Medium</p>	<p>10</p>
<p>Task : Close / fill gaps</p>

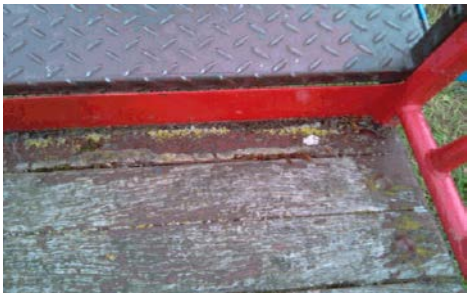
Comments, action or control required		Risk Level	Risk Score ‡
<b>Equipment</b>			
Finding : Timber - Rotting  Finding Date : 22/08/2016 Notes : Bridge plank rotting.

Low	5
Task : Replace damaged wood  Finding : Item - Parts Missing  Finding Date : 22/08/2016 Notes : Fireman's pole missing.

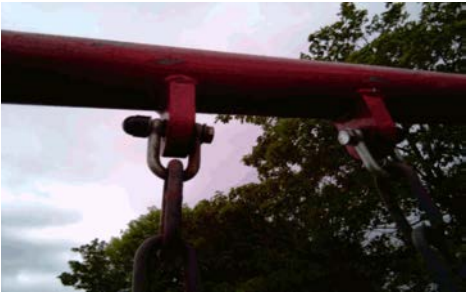
Comments, action or control required		Risk Level	Risk Score ‡
<b>Equipment</b>			
Finding :	Possible wear in bushes	Low	5
Finding Date :	22/08/2016

Task :	Remove shackle bolt and check bush and shackle pin wear, replacing if necessary		
Finding :	Dry bearings	Low	4
Finding Date :	22/08/2016		
Task :	Treat with oil, grease or silicon spray according to supplier's instructions		
<b>Surfacing - Rubber Tiles</b>			
Finding :	Algae growth on surface giving slippery conditions	Low	6
Finding Date :	22/08/2016

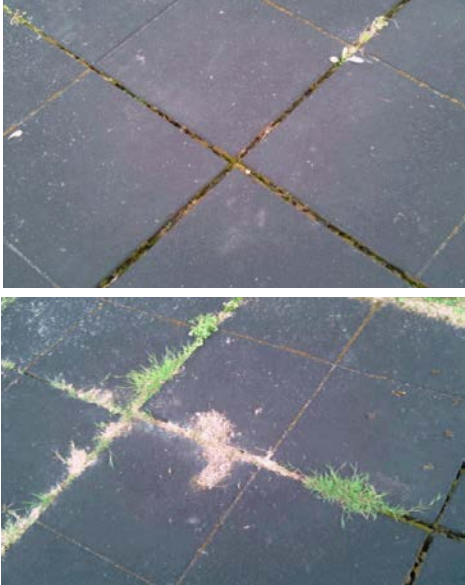
<p>Finding : Surface - Tiles - Gaps</p> <p>Finding Date : 22/08/2016</p> <p>Notes : There is no need to remove the grass growing between the tiles as it fills some of the gaps.</p> <div style="text-align: center;">

</div> <p>Task : Close / fill gaps</p>	<p>Low</p>	<p>5</p>
<p><b>The overall risk for this item at the time of inspection:</b> ‡ For Risk Score see Report Notes</p>	<p>Low</p>	<p>5</p>
