# PLAY AREA SAFETY INSPECTION REPORT

Gosford and Water Eaton Parish Council

22 August 2016

Site Owner : **Gosford and Water Eaton Parish Council**  
Site Name : Gosford and Water Eaton PC - Kidlington Play Area  
Date of Inspection : 22 August 2016  
Inspected by : Mila Yearley

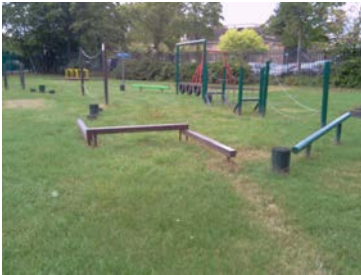
**Agility Trail**

Risk Level : Low  
Risk Score : 6

<b>Comments, action or control required</b>		<b>Risk Level</b>	<b>Risk Score ‡</b>
<b>Equipment</b>			
Finding : Item - Parts Missing  Finding Date : 22/08/2016 Notes : Wobbly beam missing.		Low	4

Task : Replace missing part / component			
<b>Surfacing - Grass</b>			
No remedial maintenance work is required at this time.			
<b>The overall risk for this item at the time of inspection:</b> ‡ For Risk Score see Report Notes		Low	6

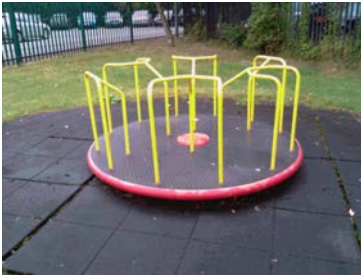
**Carousel**

Risk Level : Low  
Risk Score : 6

The item fails to meet the requirement of the relevant standard.

Comments, action or control required		Risk Level	Risk Score ‡
<b>Equipment</b>			
Finding :	Entrapment - Finger	Medium	8
Finding Date :	22/08/2016		
Notes :	The holes in the platform from the missing vertical rails create finger entrapments.

<p>Finding : Item - Parts Missing</p> <p>Finding Date : 22/08/2016</p> <p>Notes : Missing seat rails and seats, leaving exposed sharp metal corners in the free space which could cause injury.</p>

<p>Medium</p>	<p>12</p>
<p>Task : Replace missing parts</p> <p>Finding : Item - Rocking</p> <p>Finding Date : 22/08/2016</p> <p>Notes : Most of the vertical rails are loose.</p>

<p>Finding : Algae growth on surface giving slippery conditions</p> <p>Finding Date : 22/08/2016</p>   <p>Task : Powerwashing is recommended. Care should be taken to ensure that the surface can sustain high pressure washing</p>	<p>Medium</p>	<p>8</p>
<p><b>The overall risk for this item at the time of inspection:</b> ‡ For Risk Score see Report Notes</p>	<p>Medium</p>	<p>12</p>

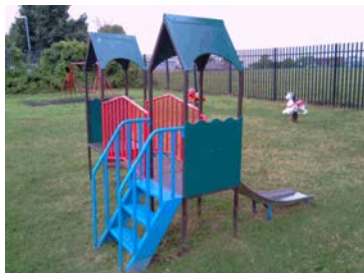
Risk Level : Low  
Risk Score : 5

Low	5
Task : Replace damaged wood  Finding : Item - Parts Missing  Finding Date : 22/08/2016 Notes : Fireman's pole missing.

Very Low	3
Task : Replace missing part / component			
<b>Surfacing - Grass</b>			
No remedial maintenance work is required at this time.

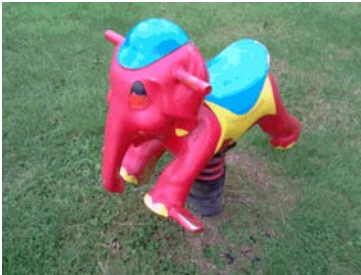
Risk Level : Very Low

Risk Score : 3

The item fails to meet the requirement of the relevant standard.

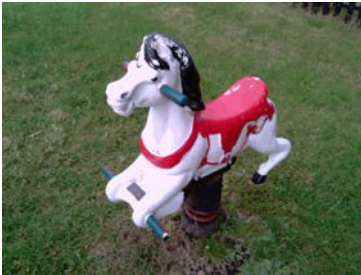
Risk Level : Very Low

Risk Score : 3

The item fails to meet the requirement of the relevant standard.

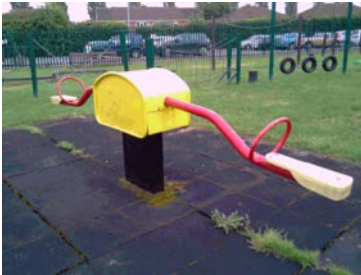
**Rocker - Seesaw**

Risk Level : Low  
Risk Score : 5

Comments, action or control required		Risk Level	Risk Score ‡
<b>Equipment</b>			
Finding : Plastics / Fibre-glass - Cracks  Finding Date : 22/08/2016 Notes : Seats are cracked.     Task : Replace item	Low	4	
<b>Surfacing - Rubber Tiles</b>			
Finding : Algae growth on surface giving slippery conditions  Finding Date : 22/08/2016     Task : Powerwashing is recommended. Care should be taken to ensure that the surface can sustain high pressure washing	Low	5

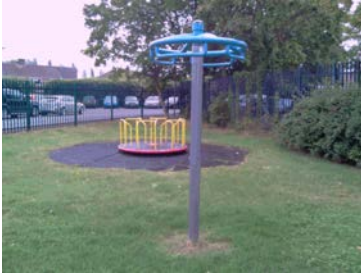
Risk Level : Low

Risk Score : 7

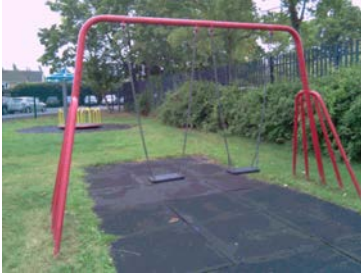
Risk Level : Low

Risk Score : 4

Comments, action or control required		Risk Level	Risk Score ‡
<b>Equipment</b>			
Finding :	Possible wear in bushes	Low	5
Finding Date :	22/08/2016

Task :	Remove shackle bolt and check bush and shackle pin wear, replacing if necessary		
Finding :	Dry bearings	Low	4
Finding Date :	22/08/2016		
Task :	Treat with oil, grease or silicon spray according to supplier's instructions		
<b>Surfacing - Rubber Tiles</b>			
Finding :	Algae growth on surface giving slippery conditions	Low	6
Finding Date :	22/08/2016

Task :	Powerwashing is recommended. Care should be taken to ensure that the surface can sustain high pressure washing

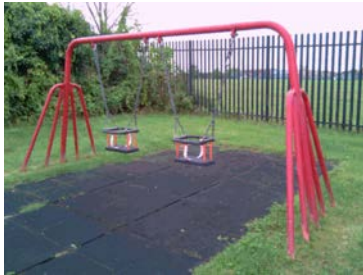
**Swing - Toddler - 1 Bay 2 Seat**

Risk Level : Very Low

Risk Score : 3
